Intel[®] Pentium[®] III Xeon[®] Processor Specification Update

Release Date: October 2005

Order Number: 244460-042

The Pentium[®] III Xeon[®] processor may contain design defects or errors known as errata that may cause the product to deviate from published specifications. Current characterized errata are documented in this Specification Update.

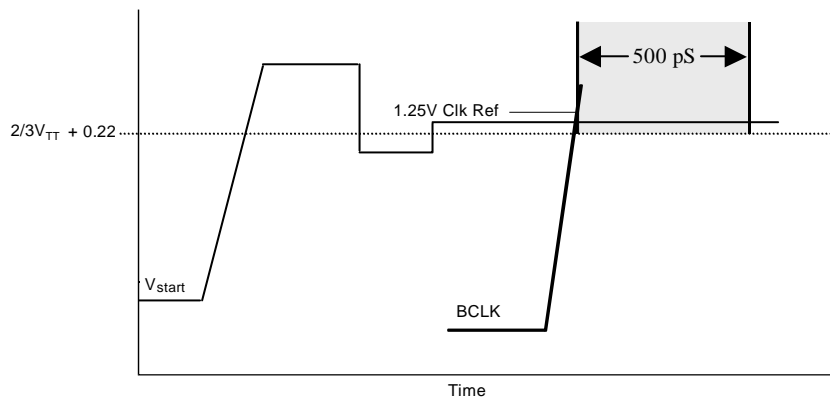
The published AGTL+ AC specification for $V_{IH(MIN)}$ is $(2/3 \cdot V_{TT}) + 0.1$ Volts.

Intel has characterized the new AGTL+ AC specification for $V_{IH(MIN)}$ on the processor's RS0# signal to be: $(2/3 \cdot V_{TT}) + 0.22$ Volts within 500 picoseconds following the rising edge of BCLK crossing the 1.25-Volt threshold. See below.

Implication: The deviation from the published specification results in decreased noise margin on the RS0# processor input. This decreased noise margin has been observed to be particularly detrimental in system environments where the RS0# processor input is being driven by an I/O buffer with a pull-up device (such as a p-channel transistor) that is switched off mid-cycle. Systems that employ I/O buffers that keep the pull-up device on for the entire cycle are significantly less affected by this erratum. The reduction in noise margin may lead to the generation of BINIT# (when enabled) resulting in a system reset, otherwise this condition may lead to a system "hang" condition.

Workaround: If a system design cannot meet the specification deviation, the following areas should be carefully examined to assure that additional margin exists in order to compensate for any deficit observed with respect to the newly characterized $V_{IH(MIN)}$ specification:

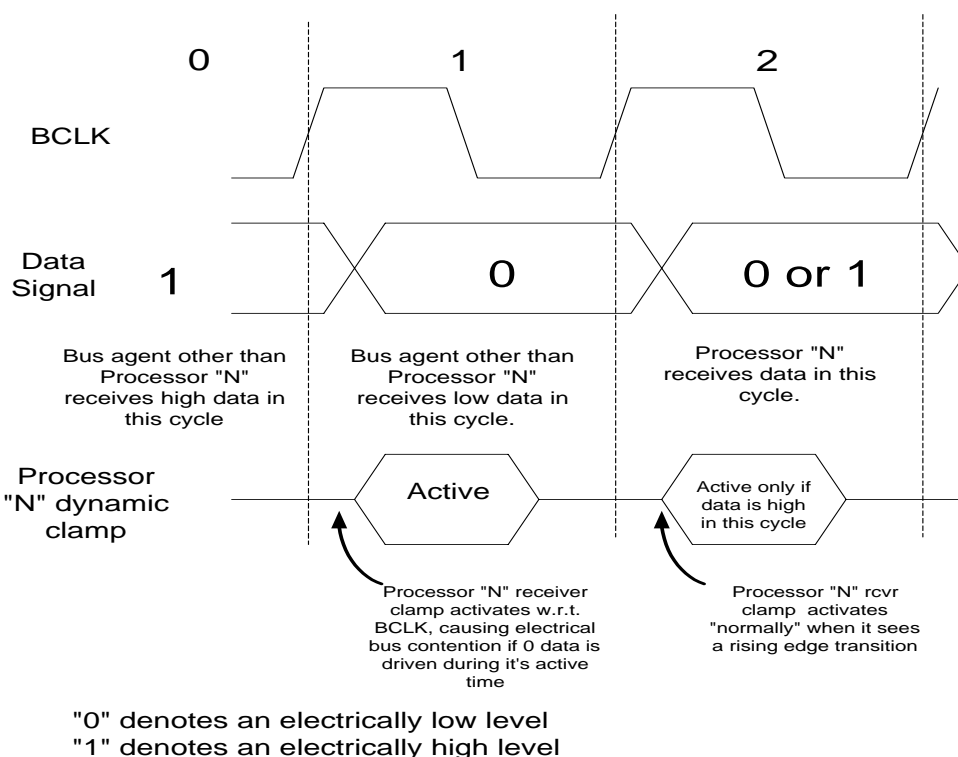
Problem: Falling edge ledge push-out and undershoot may be seen on AGTL+ data and data bus ECC signals. The AGTL+ receiver's dynamic clamp circuit activates (i.e. clamps the signal to an electrically high level) in certain cycles when data is driven to an electrically low level by another agent.

Implication: This erratum only occurs on a processor that does not receive data in that particular cycle. More specifically, this erratum only occurs when a specific processor does not receive data in the current BCLK period, but receives data in the very next period. Therefore, the processor inducing this falling edge noise (on data and data bus ECC signals) will not actually read the data in that cycle. See below for an illustration of this erratum affecting a processor denoted Processor "N". The falling edge ledges and undershoots may affect the signal quality and/or timing at agents that receive data in that cycle. Therefore, the impact of this erratum is highly dependent on system bus design.

Workaround: Evaluate system bus signal quality and timing margin at the valid receiving agent as a result of this falling edge noise. Due to dependence upon system bus design, bus layout may be evaluated to determine the need for improvements in signal quality and timing margin at the valid receiving agent as a result of this receiver-induced falling edge noise.
